IRRADIATION TESTS FOR LVPS AT UPPSALA

October 24-28 2005

- Why Uppsala ?
- Specifications
- Samples tested
- Test set-up
- Test results
- Conclusion

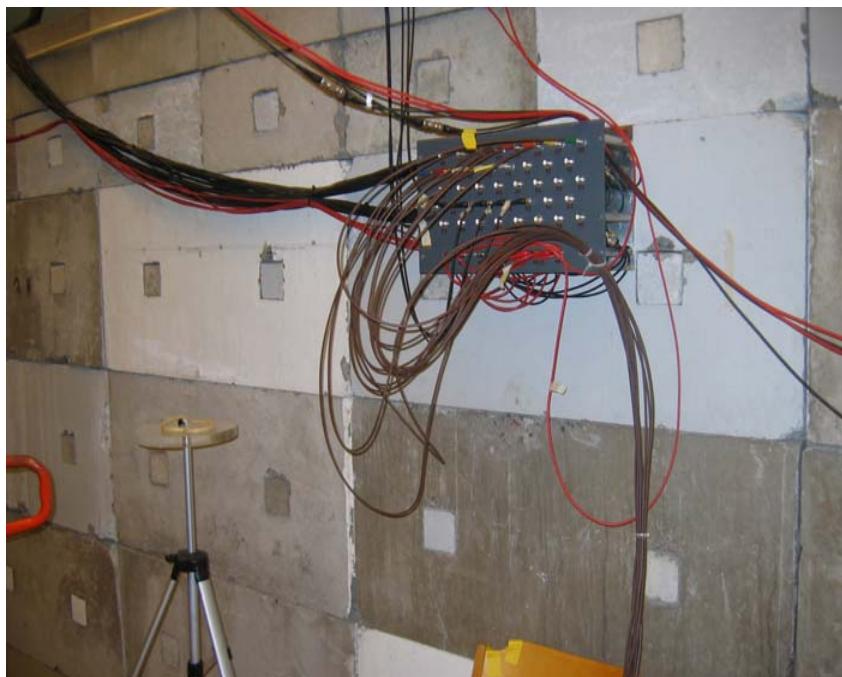
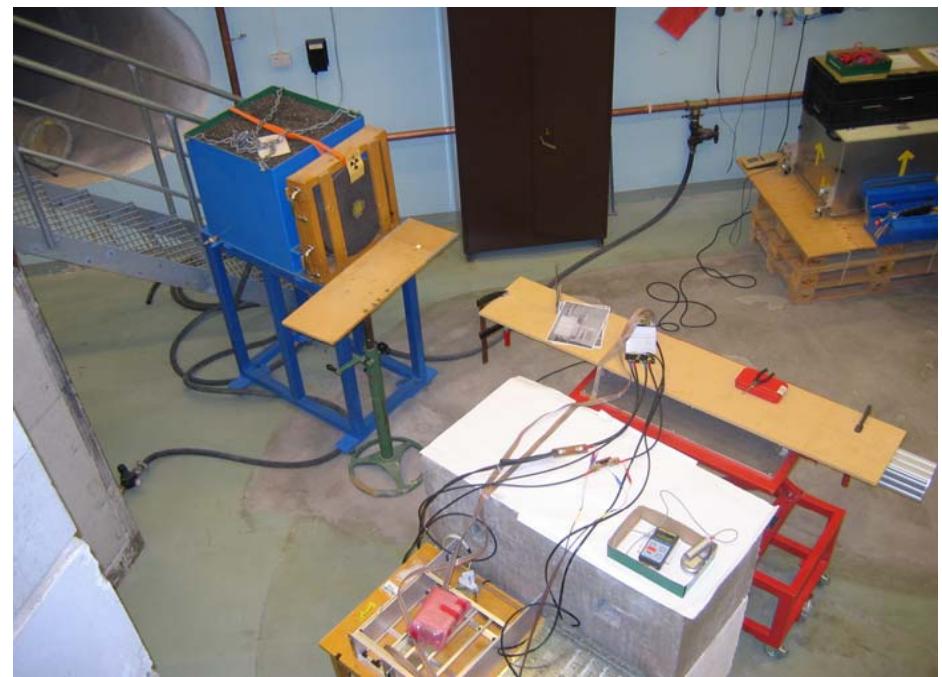
Hostile area

- Wiener Maraton:
 - AC/DC/PFC located in the hostile area but behind shielding.
 - Control and Monitoring boards located in the counting room.
 - Power modules located within the beam.
- CAEN Easy:
 - SY2527 located in the counting room for control and monitoring.
 - Power modules located within the beam.

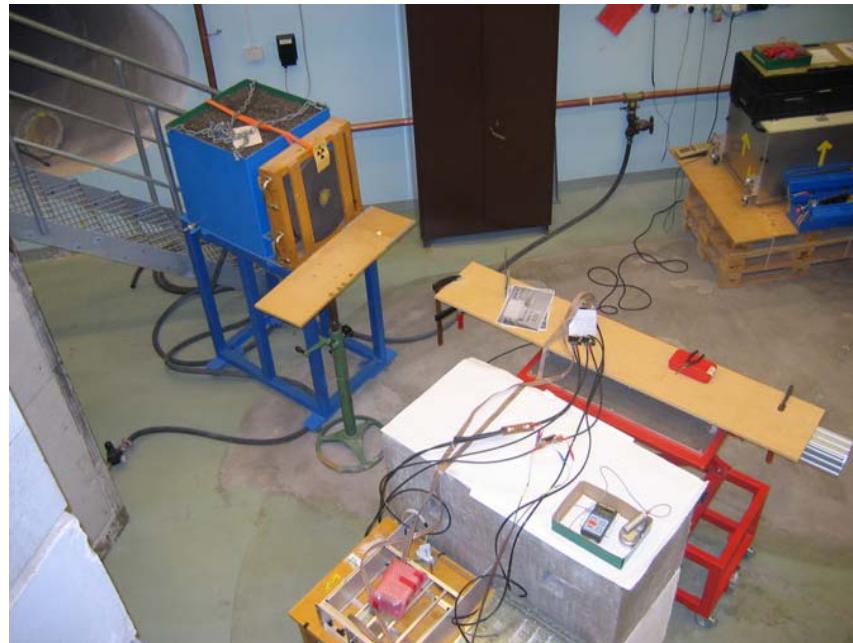
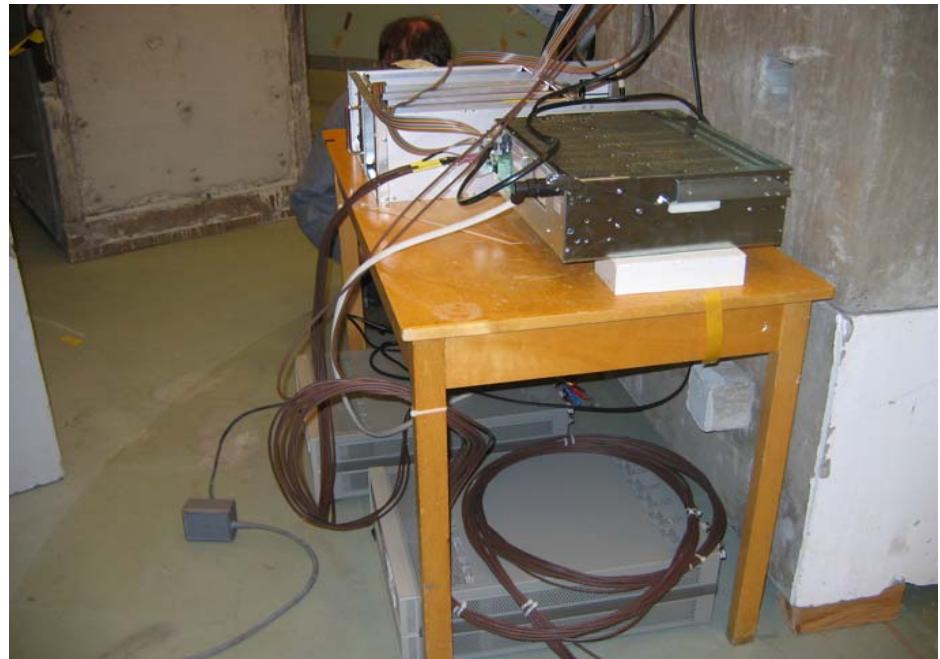
- Wiener Maraton:

- At $5 \cdot 10^{10}$ p/cm 2 the fuses of the electrical distribution blew.
- Strong suspicion that the PFC module, although located behind concrete blocks failed because of radiation environment.

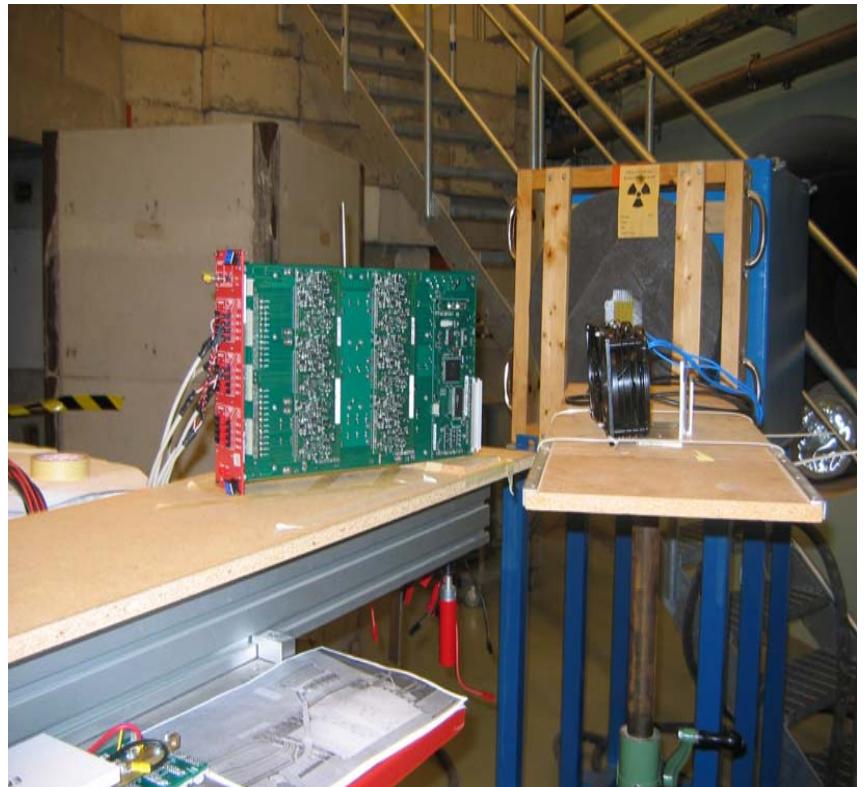
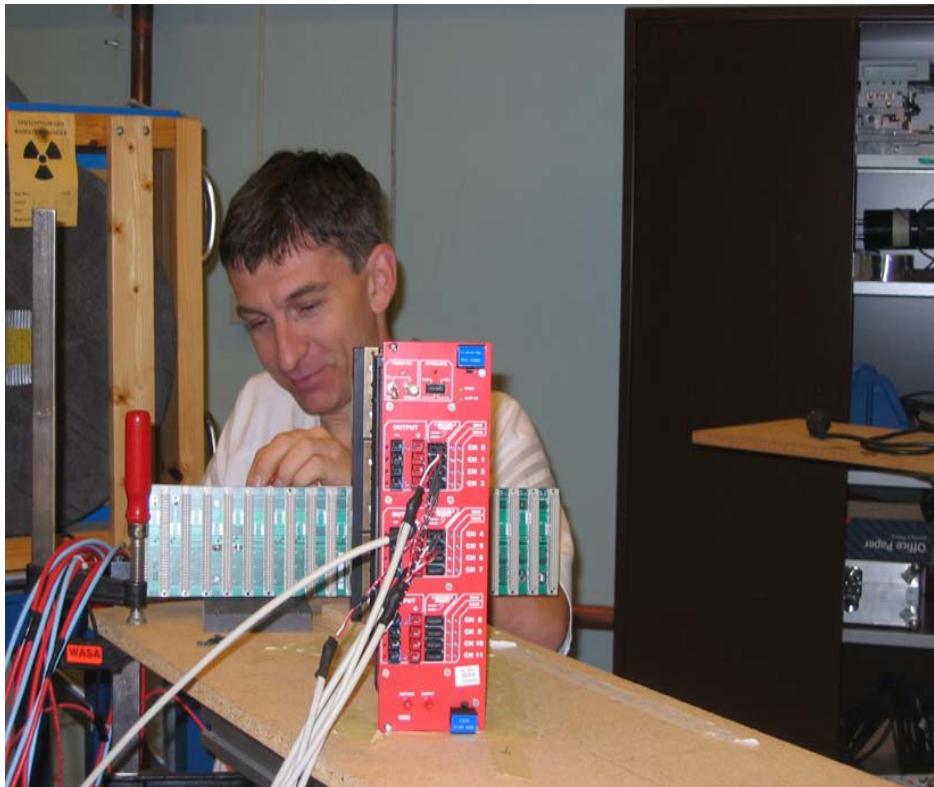
Backplane to replace Easy crate

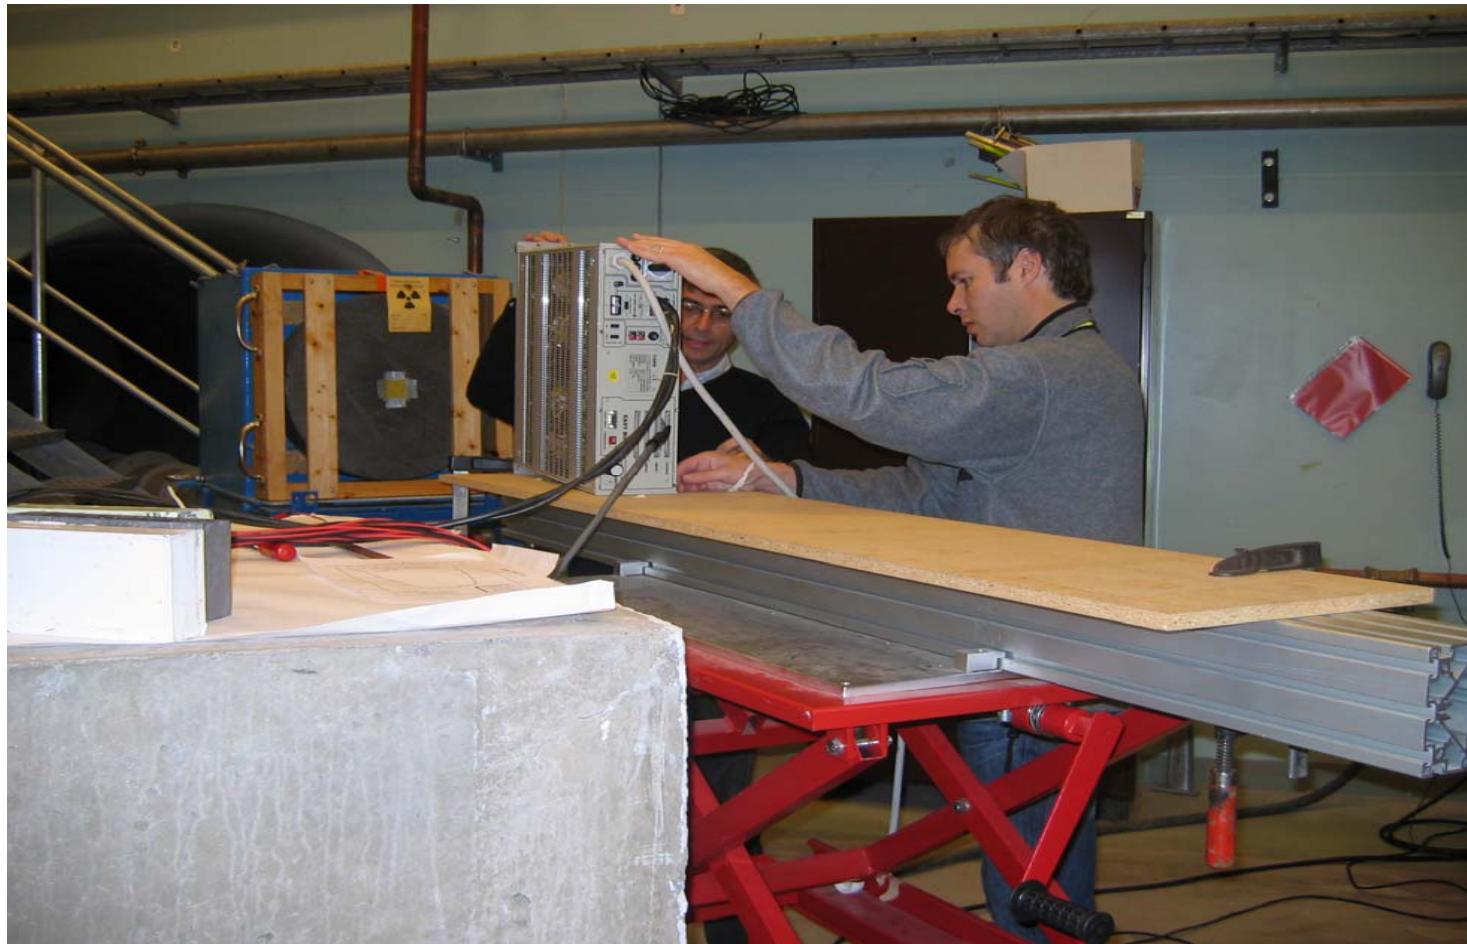
A 3486

- Test in 2 parts:
 - First part up to $2.5 \cdot 10^{10}$ p.cm².
 - Stop proton beam for therapy.
 - Restart proton beam.

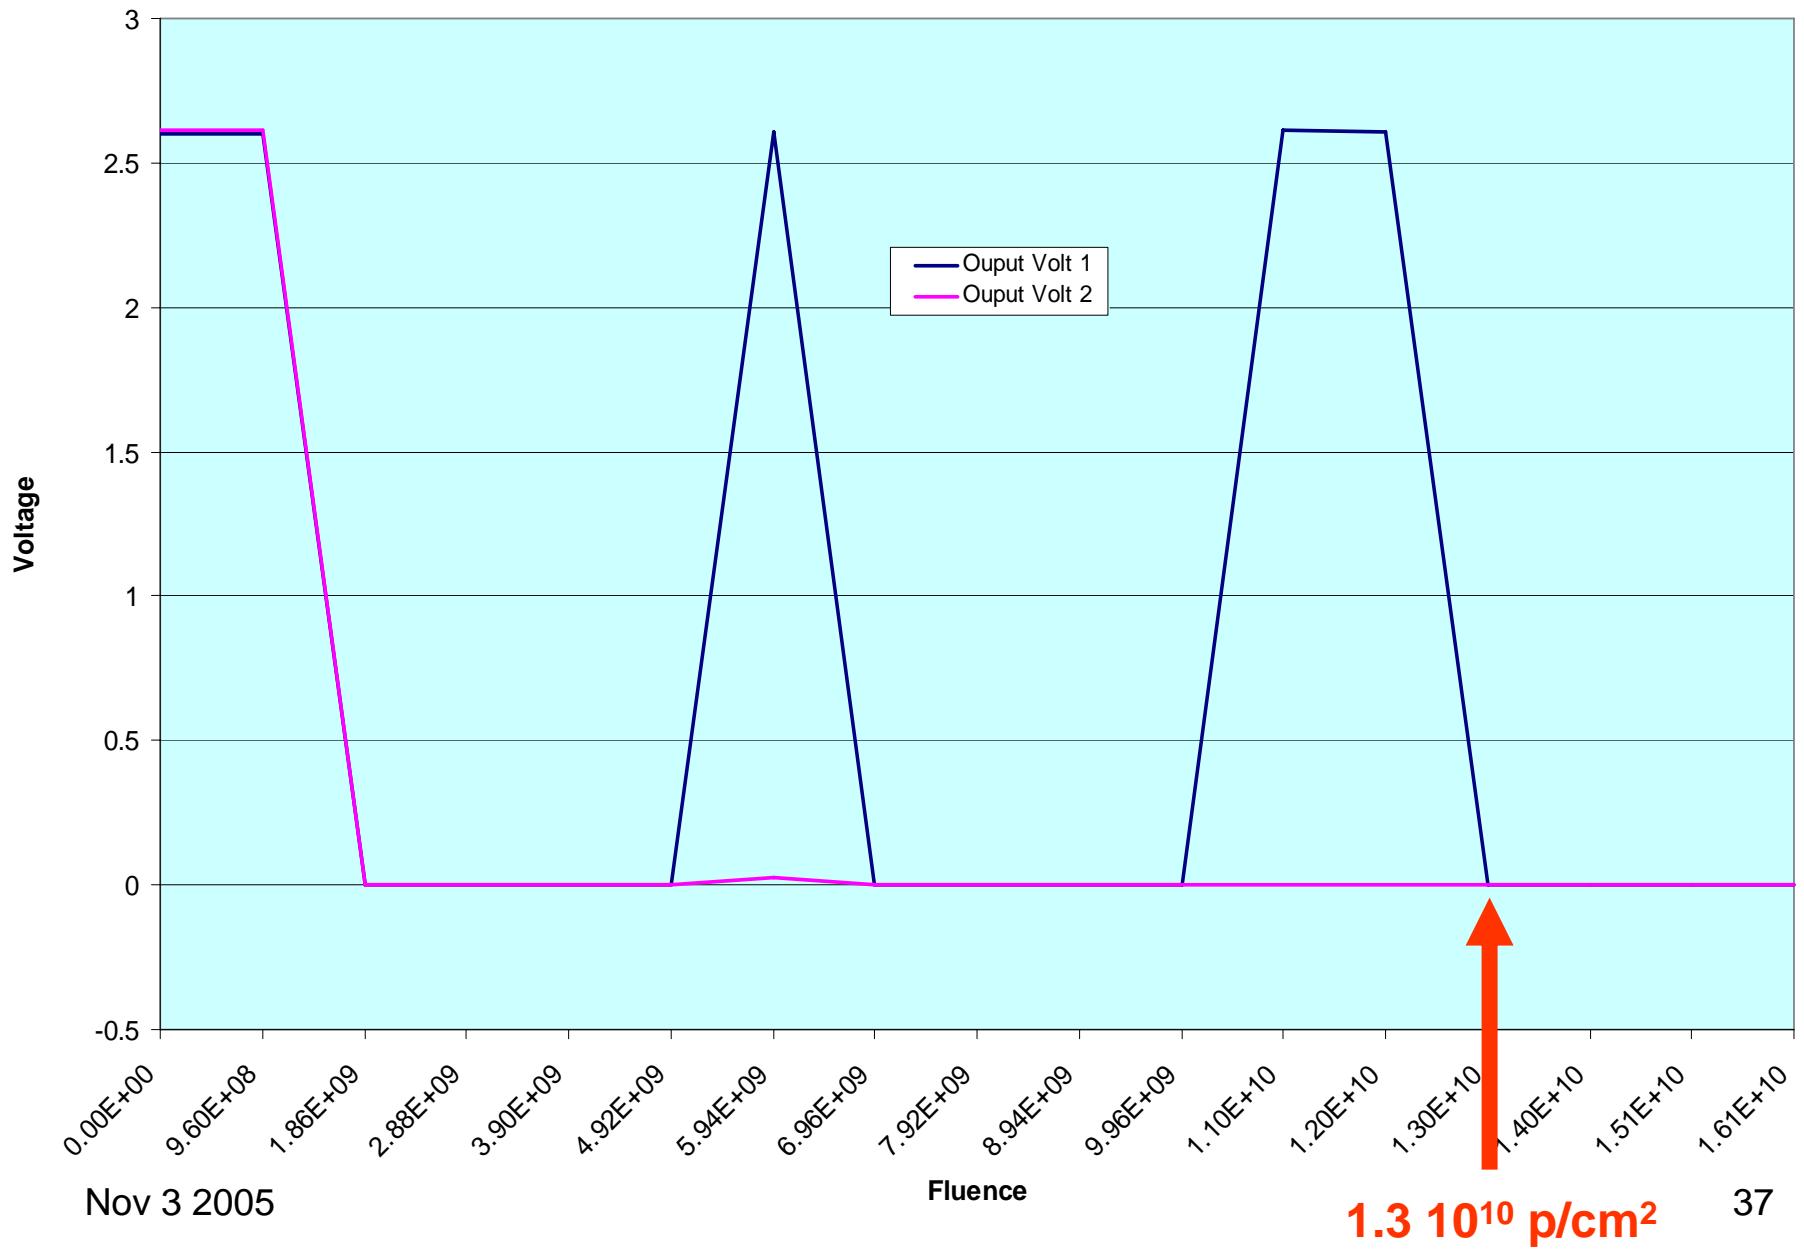
CAEN A3016 Output Voltage

1.3 10^{10} p/cm²
